5.4 Reach 2

Surveys of Reach 2 (RM 26.6 – 19.1) were completed on September 15 through 18, 2003.

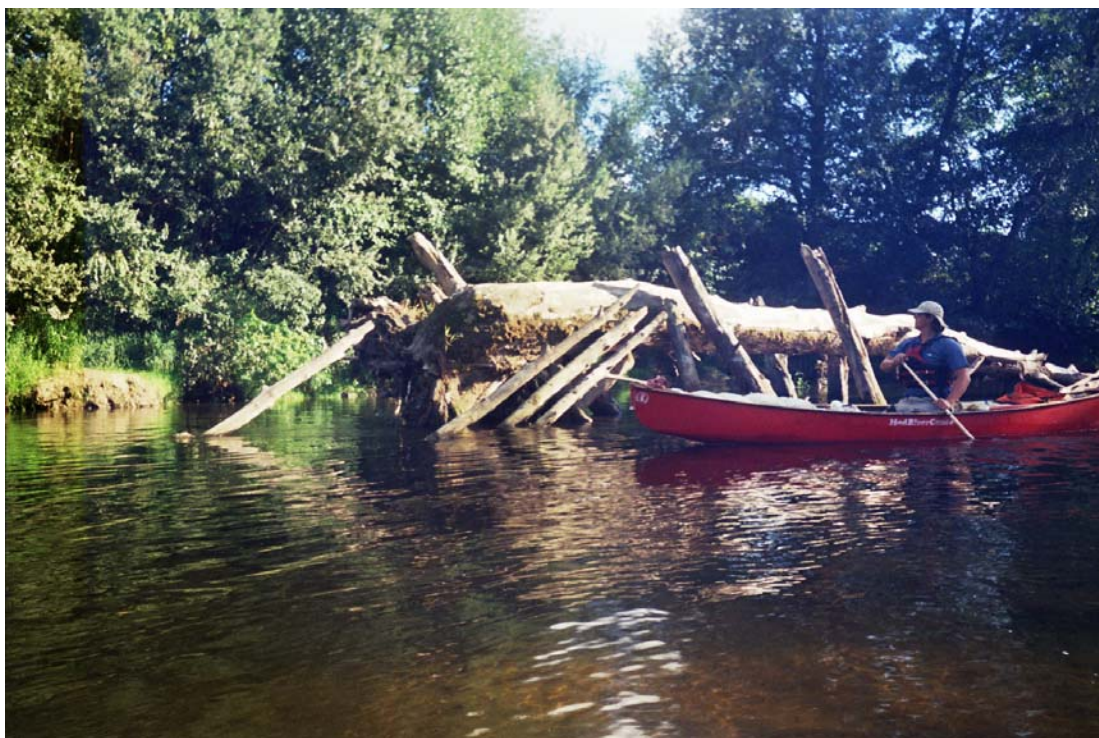
Photo 5-5. Reach 2, Station 6: Logjam at the inside margin of a pool.

Reach 2 has the highest sinuosity and density of pools in the study area and contained two separate logjams (Photos 5-5 and 5-6). The sinuosity is due in part to the fact that the river generally crosses the floodplain in this reach and is not confined by any anthropogenic features other than the State Route 516 bridge (Photo 5-7).

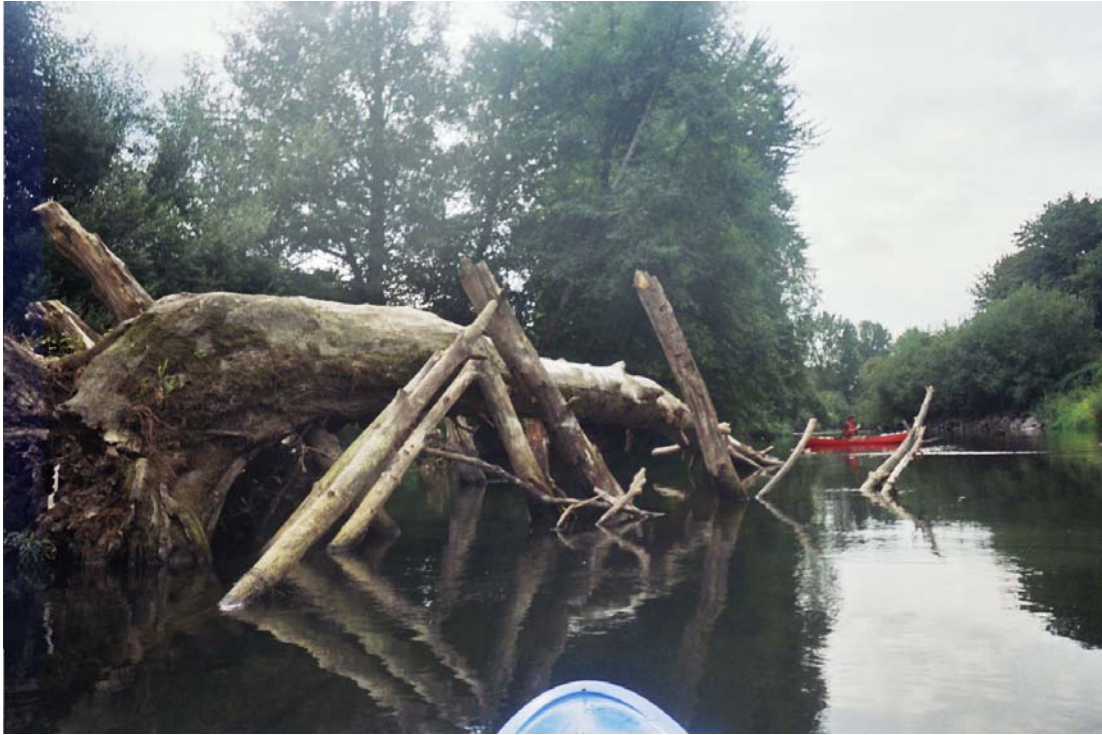
Photo 5-6. Logjam at Reach 2, Station 6 in the Lower Green River.

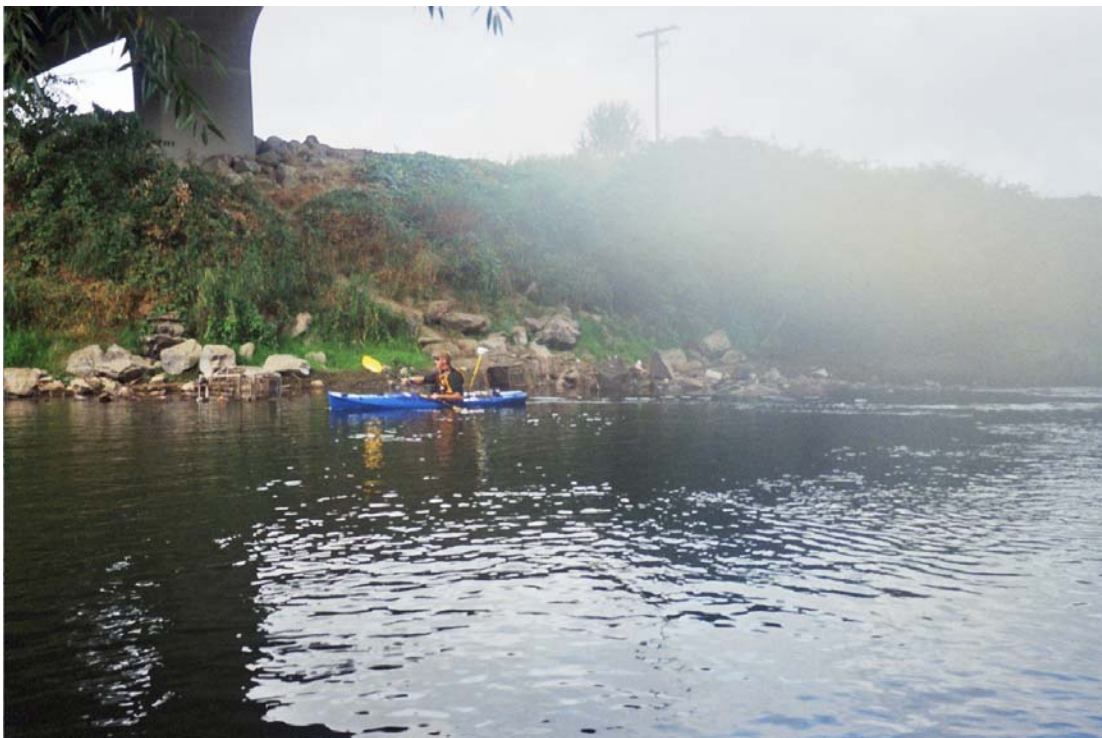
Photo 5-7. State Route 516 bridge crossing in Reach 2, Station 25 of the Lower Green River. A large pool is formed here by the constriction of the bridge abutments.

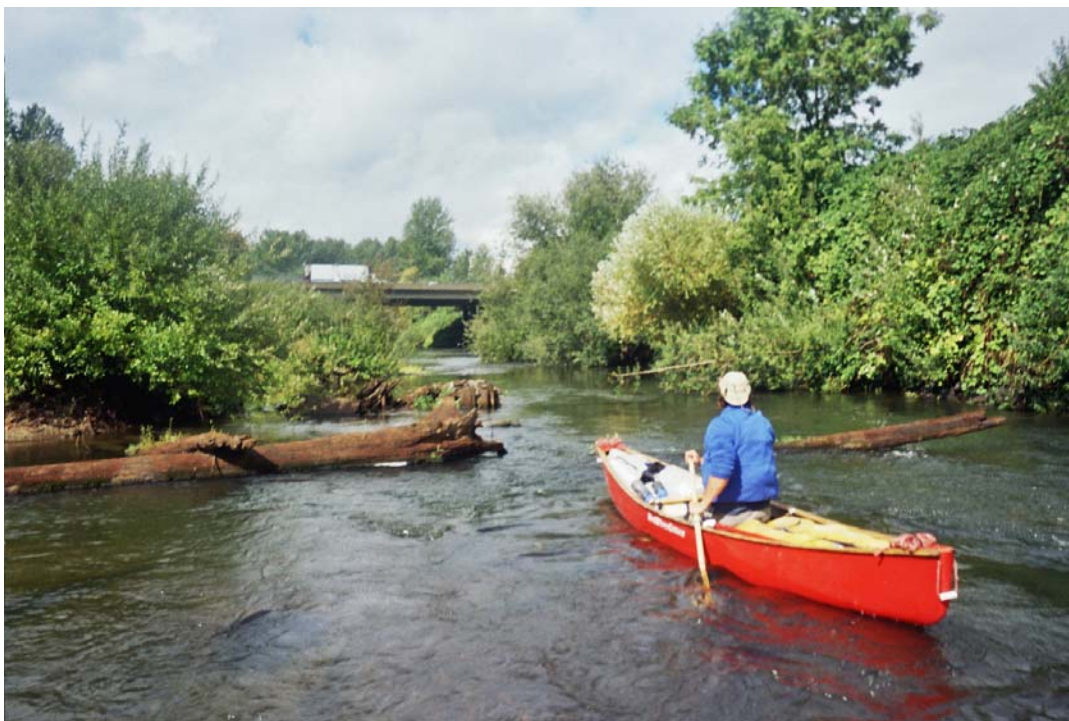
Photo 5-8. Downstream right bank portion of the large gravel depositional zone at reach 2, Station 15 in the Lower Green River.

There were four gravel storage areas in Reach 2 (Photos 5-8 and 5-9). One potential gravel storage area was identified on the inside of a meander bend near Reach 2, Station 3, where no gravel deposition was occurring due to artificial constriction of the channel. Downstream gravel transport appears to end at Reach 2. Pebble counts were taken at the following four stations: 1, 10, 12, and 18 and the results were presented in Section 5.2 and Figure 5-7.

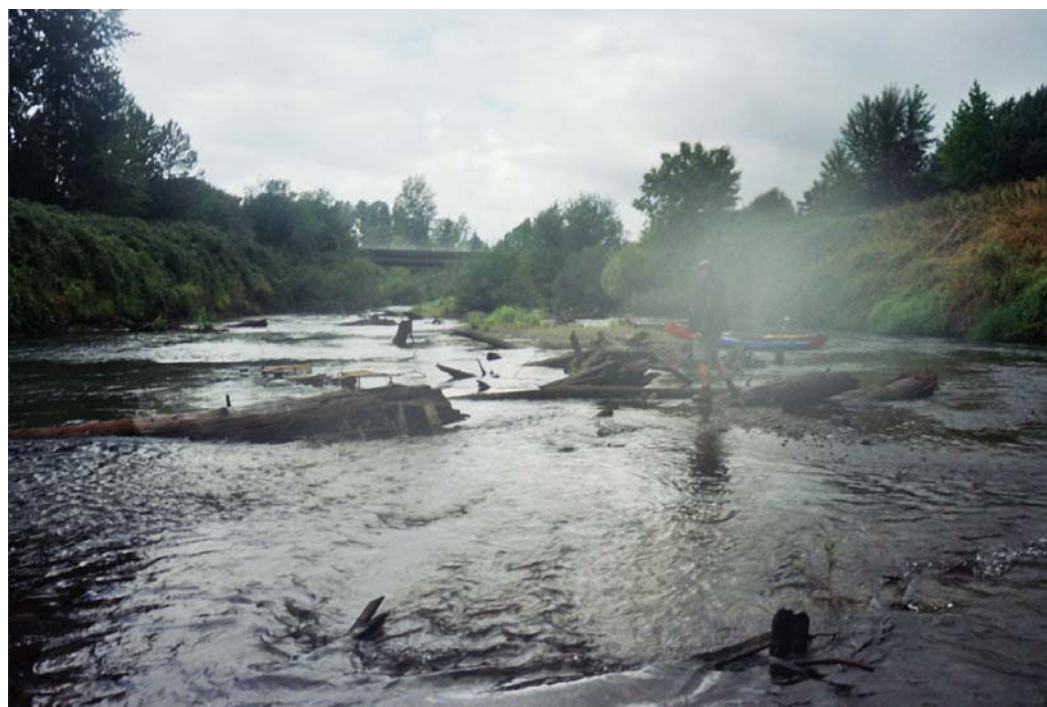
Photo 5-9. The upstream end of the large depositional area at Reach 2, Station 15. Large quantities of woody debris and very small pools make this reach important salmon habitat.
